FIELD EXPERIENCES WITH RUB INDUCED INSTABILITIES IN TURBOMACHINERY*

David G. Goggin
Radian Corporation
P.O. Box 9948
Austin, Texas 78766

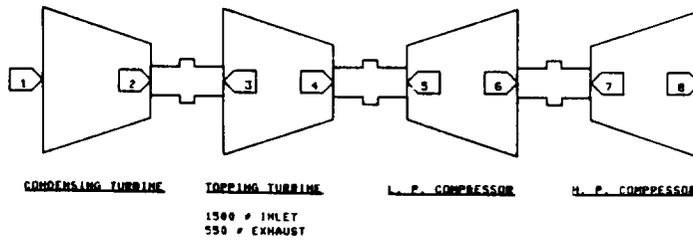
Figure 2. - Schematic of the Syn Gas Compressor.

Figure 2 shows a schematic of a 20,000 H.P., 11,000 rpm Synthesis Gas Compressor train composed of a condensing turbine, a back pressure turbine, a low pressure and a high pressure compressor. The back pressure turbine, or topping turbine as it is referred to, is a two stage 12,000 H.P. drive through turbine using 10.34 MPa (1500 psi) inlet and 3.79 MPa (550 psi) exhaust steam. The first and second critical speeds are 6750 rpm and 13,000 rpm respectively as determined from proximity probe data during start-ups and overspeed trip tests. The 5800 kg (913 lb) rotor is supported in a 12.7 cm (5 in) diameter bearing at the inlet end and a 7.6 cm (3 in) diameter bearing at the discharge end. Both are 5 shoe tilting pad bearings with a load on pad orientation. This machine, like many others, tends to show some low level (2.54 μm or 0.1 mil) subharmonic vibration over a broad band of about 30-150 Hz during normal operation.

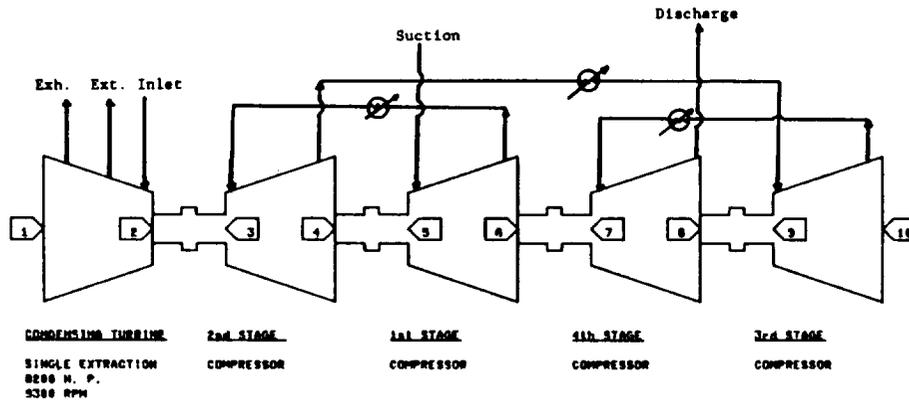
Figure 8. - Schematic of the CO₂ Compressor.

Figure 8 shows a schematic of a CO₂ compressor train driven by a 8200 H.P., 9300 rpm, single extraction, condensing turbine. The 19,240 kg (3030 lb) rotor was supported on 15.2 cm (6 in) journals with sleeve type bearings. The first and second critical speed were approximately 4900 rpm and 10,150 rpm respectively as determined from proximity probe data during start-ups and overspeed trip tests. This unit had been in operation over nine years with no reported vibration problems except for occasional temporary bows during start-ups. The machine's susceptibility to thermal bows was due to short warm-up and start-up periods that were necessitated by plant design. Due to the trouble free operation of the unit, it had only been overhauled once five years after installation. The train was located outdoors with a protective roof over it.

During a brief outage in the summer, the bearings were inspected and found to be acceptable. But the bearing's oil seals were replaced at the governor end due to excessive leakage. These seals were noted to be tighter than normal with 50-75 μ m (2-3 mils) diametral clearance. During the start-up, another vibration excursion occurred. The turbine had reached minimum governor speed and the speed was being increased slowly as needed. At 9250 rpm, the vibration levels suddenly increased from about 25-38 μ m (1.0-1.5 mils) to about 76 μ m (3 mils) and fluctuated rapidly between 25-38 μ m (3 and 4 mils). The thrust monitor showed an alert condition also. The condition lasted two to three minutes and it was found that a slight increase in speed caused the vibrations to return to normal.

During a rainstorm several days later, another vibration excursion occurred lasting less than a minute with symptoms very similar to the previous excursion. The problem subsided when the speed was increased from approximately 9300 rpm to 9500 rpm. Several more vibration excursions occurred during rapid changes in weather conditions over the next few weeks.

The problem was thought to be due to a transient rub condition since:

- 1) the condition was closely related to weather conditions,
- 2) the wide fluctuations in the subharmonic component,
- 3) that slight increases in speed caused the instability to cease.
